## **St Andrew's Bedford**

### **Faculty application 2025: remedial window repairs**

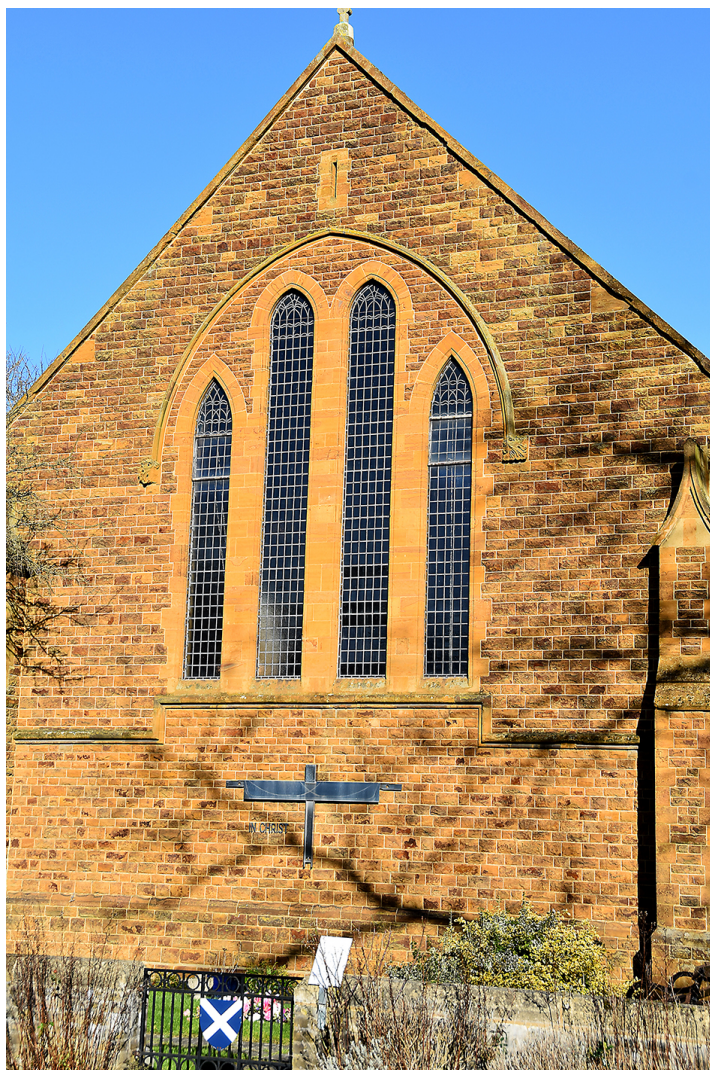
Remedial work is needed on the West Window (wl) namely *releading the lower two panels and other remedial repairs, and add additional perimeter lead and repair (requiring an internal scaffold to be erected).*

More significantly, a crack has opened up on the west wall that has pulled the centre light away from the stonework. With the lack of support from the mullion, the lower portion of the centre light has been subjected to regular flexing from atmospheric conditions, which in turn has resulted in the weakening of the lead matrix. The lower two panels of this light need re-leading and an additional perimeter lead added to make up for the widening of the light.

There is damage to the northernmost most light. The division lead at the lowest division has perished on the outside, leaving the lower row of quarries at that division unsupported and in danger of falling out. The lower two panels of this light require removing and the leadwork repaired.

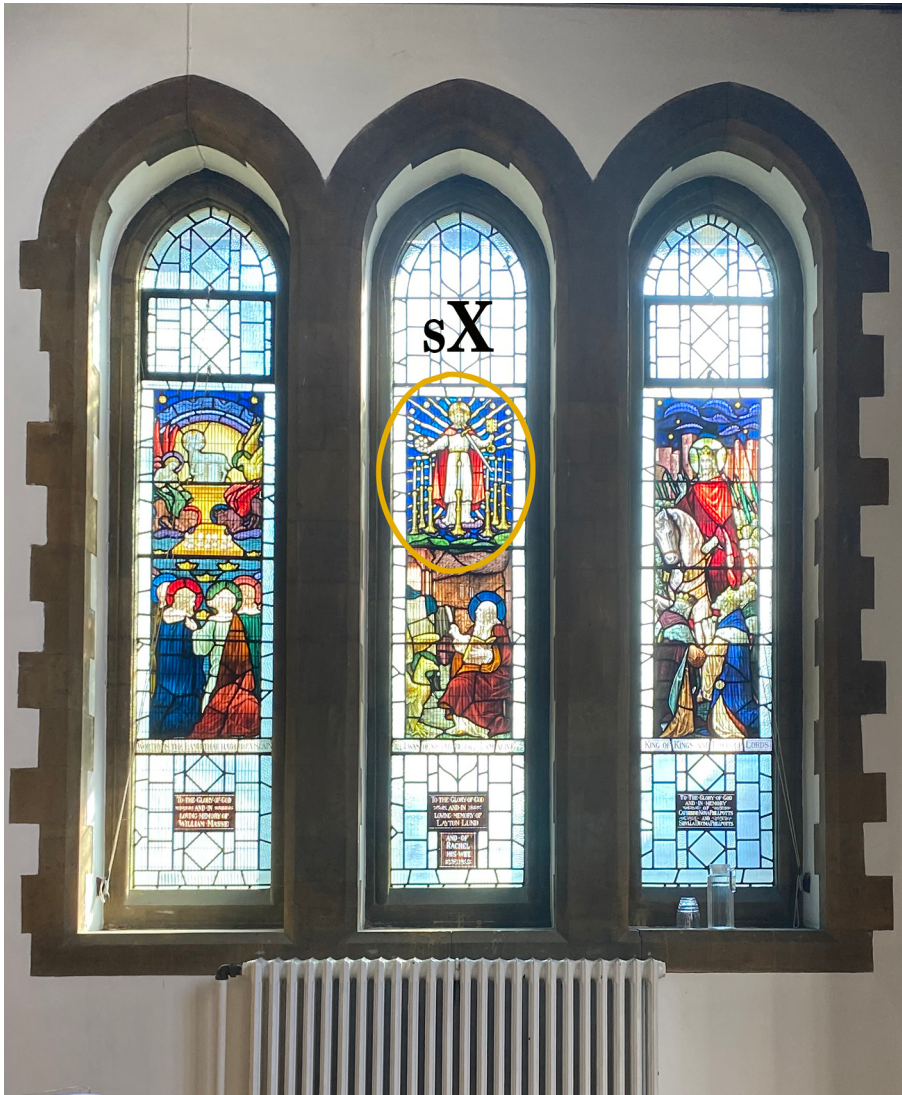
Relead the *upper panel of the centre light (depicting Christ holding the keys to heaven)* on window sX

In addition, a bowing to the upper panel of the centre light has been identified in window sX (depicting Christ holding the keys to heaven), requiring the panel to be removed and re-leading.

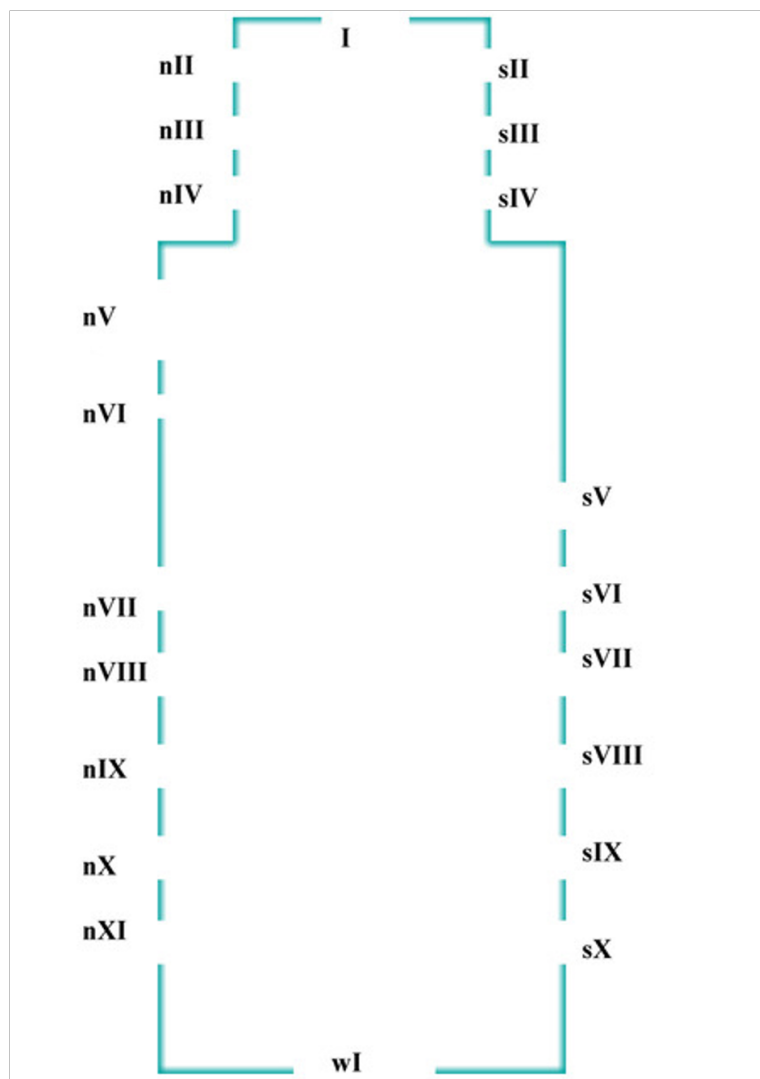
## Window plan

*Pointing and putty repairs are required to windows sVI, sVIII, sIX, nIX, & nV (see plan at foot of document)*

The survey identified a number of windows in need of pointing and puttying (see plan at foot of document).
